**City of Edinburgh Council Trams York Place to  
Newhaven Archaeological Investigation on Leith Walk  
Data Structure Report  
Project 4870**

## Data Structure Report

**Project Number:** 4870

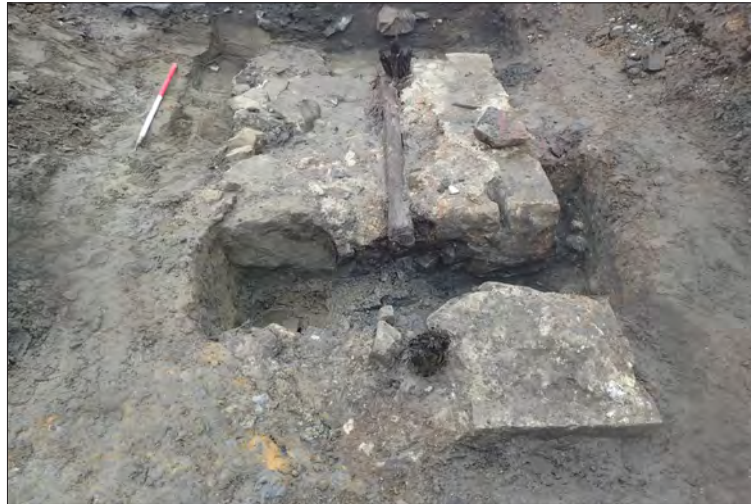
*Plate 2: Stone foundation (6012) with timber posts cut by service trench*

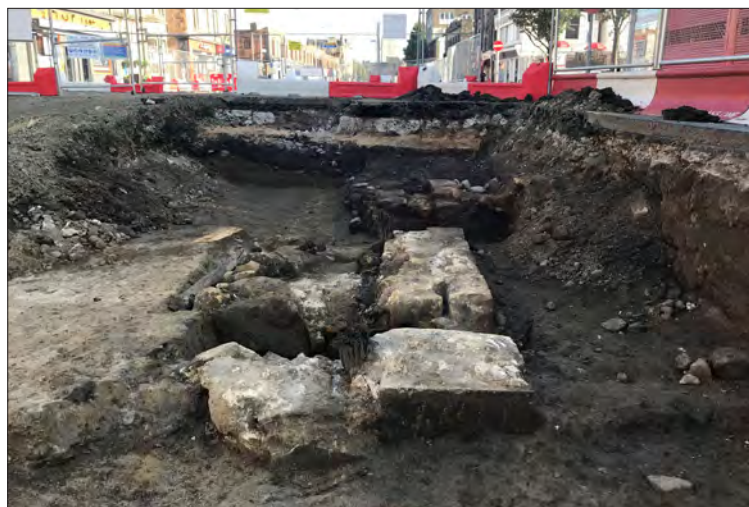
Plate 5: Stone foundation (6012) with drain and section, from the south

- 6.7 Deposit 6013 sealed deposits that were associated with the stone base (6012) and what appear to be drains on either side which extended beyond the northern limit of the stone base and had been cut into deposit (6013). To the east there were two possible drains, (6028) had been cut by the gas pipe that runs along the eastern side of Leith Walk. The surviving part of the ditch had steeply sloping sides and a rounded base and was 0.32 m wide and 0.35 m deep; the fill (6027) consisted of grey black silty sand with stones. Fragments of animal bone, glass and white earthenware pottery were recovered from this fill. A thin layer of grey clay (6023) partly covered drain 6028 and the adjacent drain 6022. Drain 6022 was 0.78 m wide and 0.5 m deep with steeply sloping sides. The upper fill of the drain appears to have been re-used or remodelled as two parallel lines of stones had been placed along either side to form an open drain or gully with a thin layer of small stones to form the base (6039). Below this was a compact layer of sand and iron slag (6037) 0.12 m thick. Below this was the main fill of the ditch (6038) that was 0.24 m thick and consisted of a green grey coloured sand with fragments of iron slag. This sealed the lowest fill (6043) which was 0.12 m thick, consisting of grey silty sand with stones. To the west of drain (6022), the main deposits (6013) sealed a thick layer of grey/black silty clay that partly sealed the stone foundation (6012), this layer was 0.3 m thick. Immediately to the west was the remains of another drain that had been cut from layer (6013) and cut through layer (6015). The drain (6020) was 0.3 m wide and 0.15 m deep with sloping sides and an overhanging lip, the fill (6016) consisted of green/grey silty sand; the surviving section of this drain had been partly truncated by services.

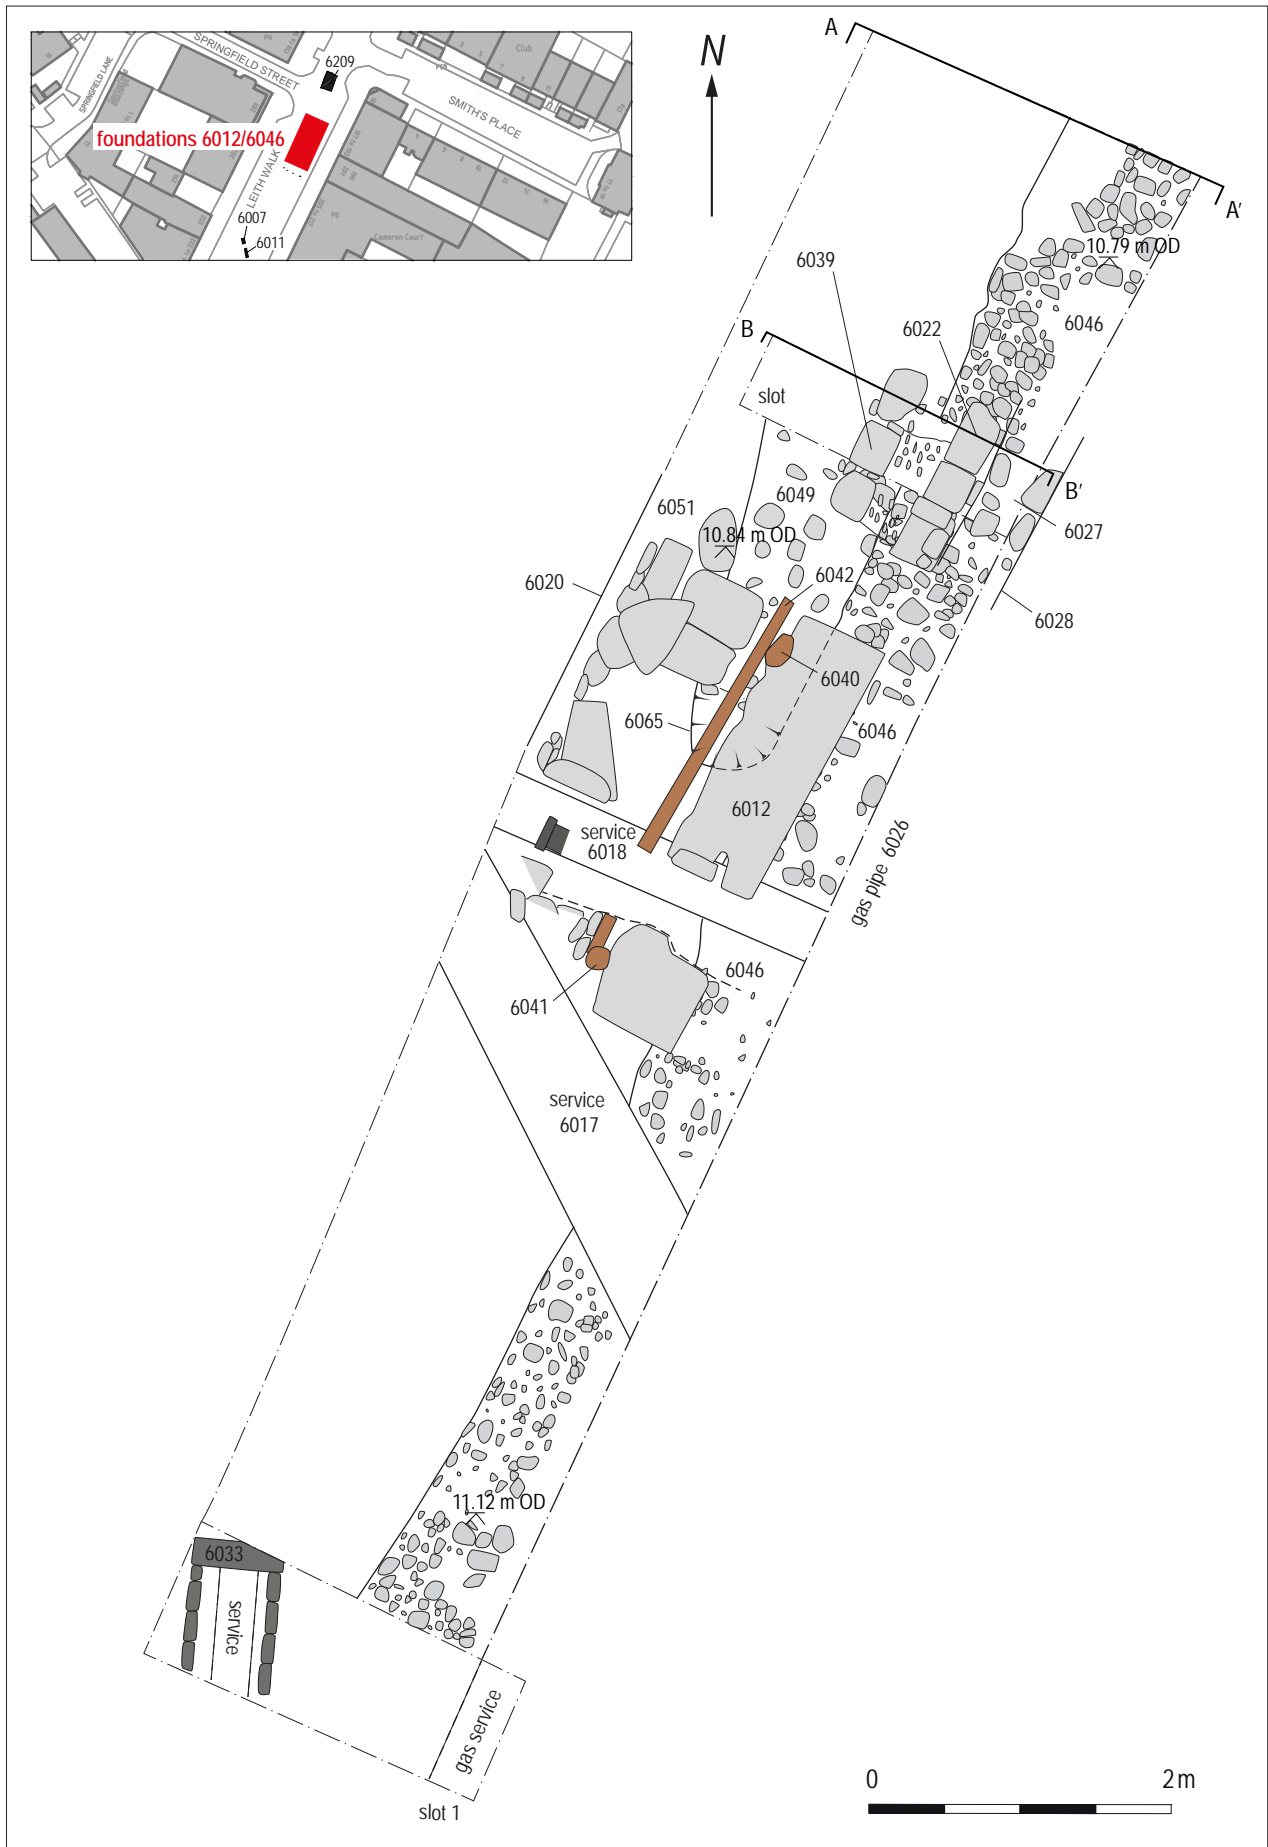
Figure 3: Plan of cobbles, foundation base 6012 and drainage channel

- 6.8 Further excavation revealed that the stone base (6012) was partly built over an extensive road surface that was uncovered 1.5 m below the current road level. The surface (6046) was constructed from sub-rounded and sub-angular whinstone rubble of different sizes set within silty sand. The surface extended for 11.70 m and was 0.80 m wide with a maximum thickness of 0.08 m. Below the stones that formed the road was an extensive deposit, possibly a drain (6051), that the road seems to have been built over; an open drain was retained on the north-west edge of the road. Pieces of wood were recovered from the edge of the drain. The road surface was truncated by a trench for a gas pipe trench along the south-east side and a service trench to the south. This service trench was unusual in that the sides of the trench had thick wooden shoring on both sides and similar planks of wood were laid over the top, a fire clay pipe was uncovered at the base of the trench.

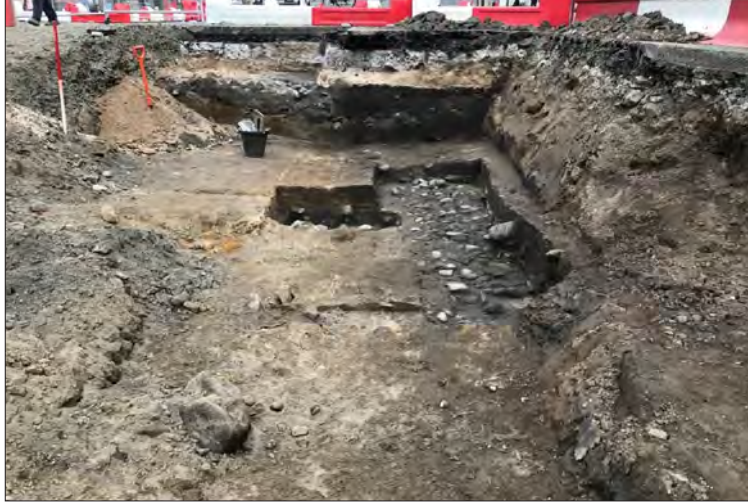
*Plate 6: The stone foundation was removed to reveal a cobbled surface (6046) below, from the south*

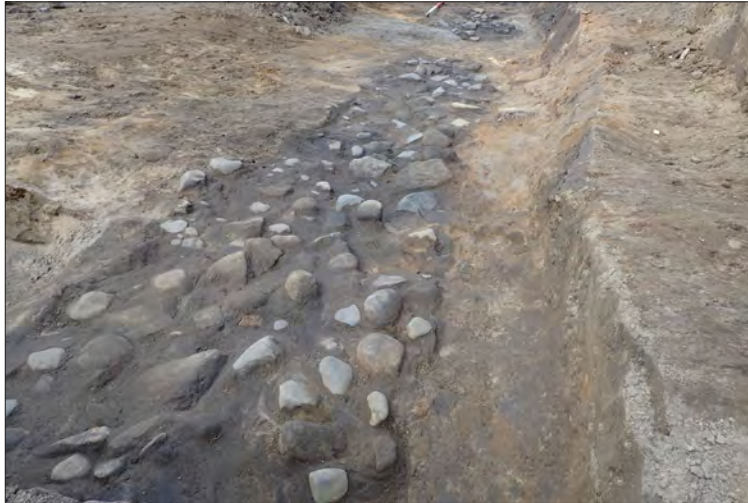
*Plate 7: Full extent of the cobbled surface (6046), from the south*

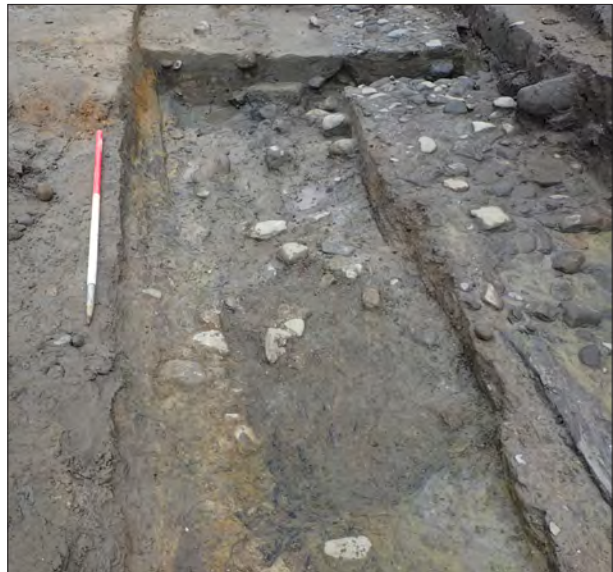
Plate 9: Ditch 6022 at north-west side of the road surface, cut into the natural subsoil

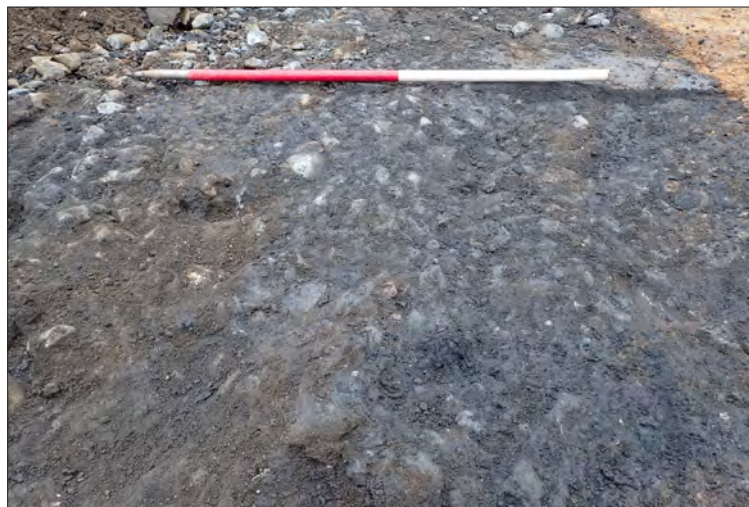
Plate 14: Metallated road surface (6209) at Section 62. bridge

6.17 Another road surface (6209) was recorded consistently in most sections along Leith Walk at a depth of between 0.7 m and 0.9 m below the current road level at the approximate formation level for the tram track slab. This road surface had a core of sub-angular medium sized stones with dark silty sand and was between 0.25 m and 0.3 m thick. Unfortunately, the full width of the road was not uncovered at any point during the bulk excavation as the surface had been cut by various services, but a section of road edge or kerb was visible in section 62, where a possible open drain or gully was uncovered and was built of two parallel lines of large stones (6223).

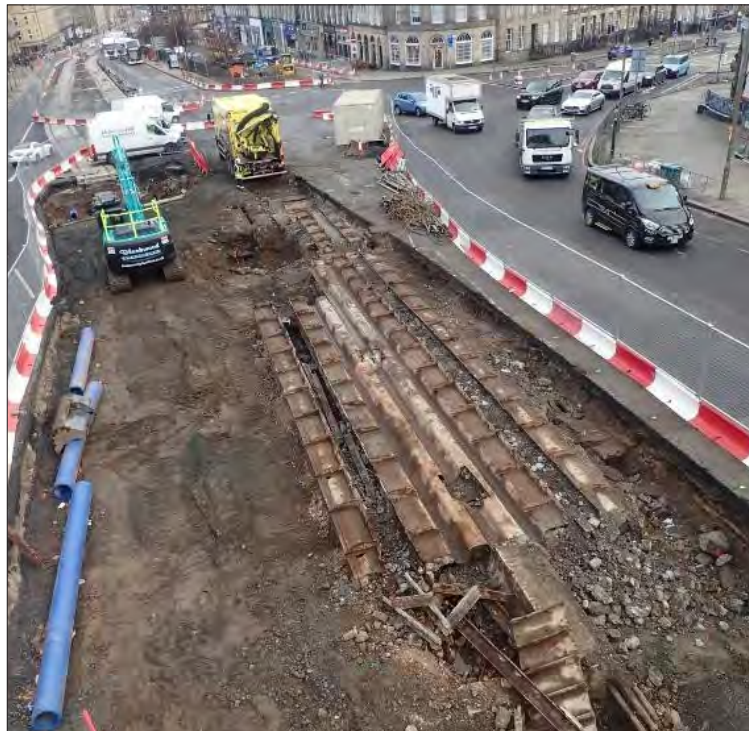
*Plate 18: Overhead view of main chamber and cable tunnels at Antigua Street/Baxter's Place*

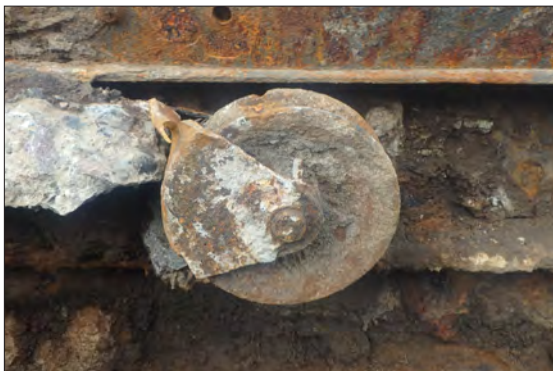
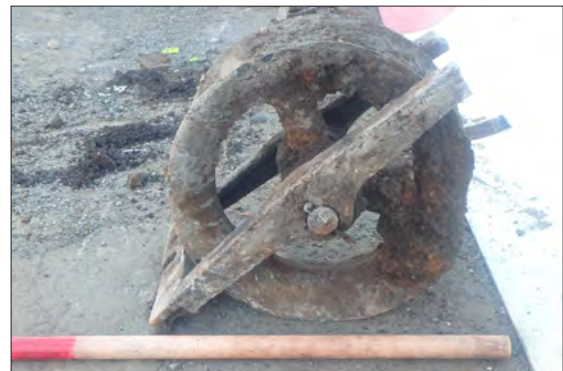
*Plates 21 and 22: Small wheel in situ suspended from the roof of the chamber at Antigua Street/Baxter's Place and a wheel found over the roof of the main chamber*

tunnels were uncovered along with two small iron wheels that were part of the cable pulley system (finds 831 and 832 found inside structure 0314). Part of the structure was modified and used as an air raid shelter, during World War 2. Finally, in 2010 the access corridor that runs under the main road was filled with foam concrete making it inaccessible today.

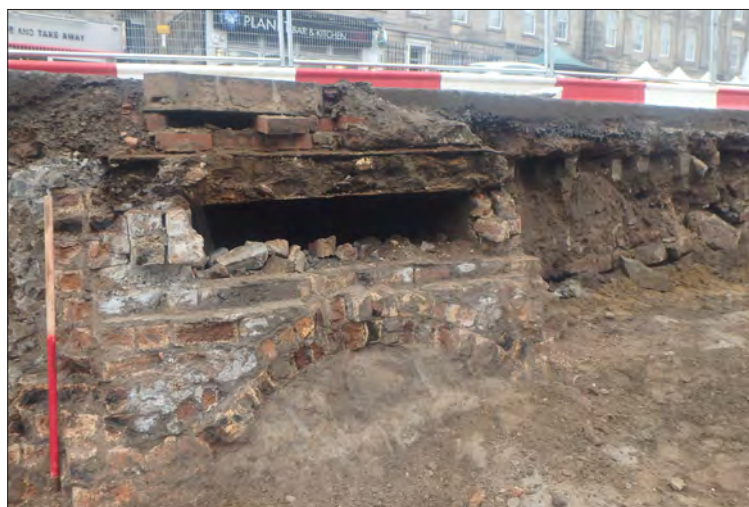
*Plate 28: entrance to the corridor running north-west/south-east with arched roof partly filled by foam concrete*

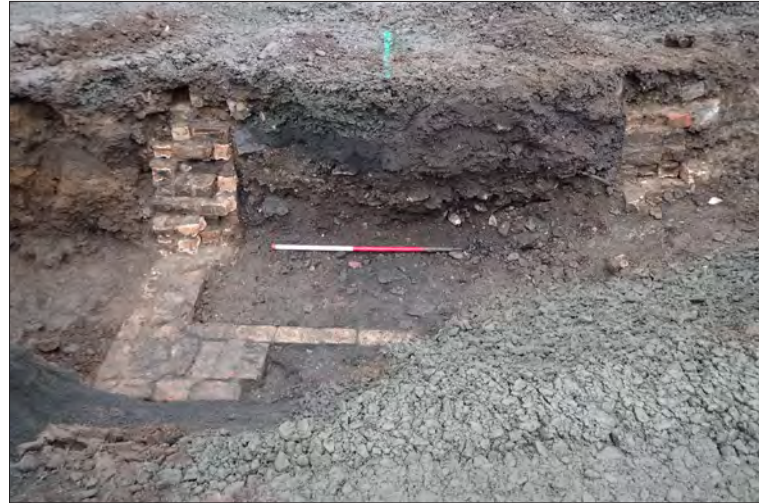
Plate 29: Remains of cables tunnel (7308) discovered in section at south of the rail

6.32 More remains of the cable tunnel were recorded in Area 73, from McDonald Road to Middlefield including a section on the south side of the rail bridge but it was in poor condition and measured 3.2 m in length, 2.4 m width and survived to a height of 0.8 m (7308). This section of the cable tunnel was built with yellow or red bricks (230 mm by 110 mm by 90 mm) stamped with the "ETNA" brand name and a grey mortar; the roof did not survive.

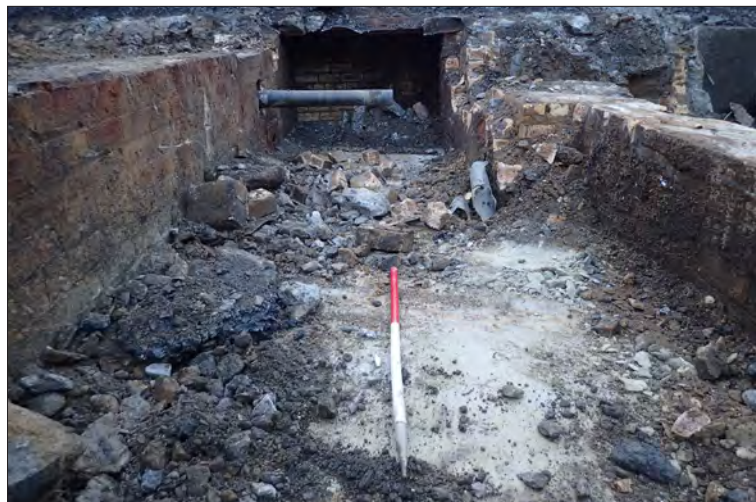
Plate 31: Area 73, inside detail of cable tunnel (7314)

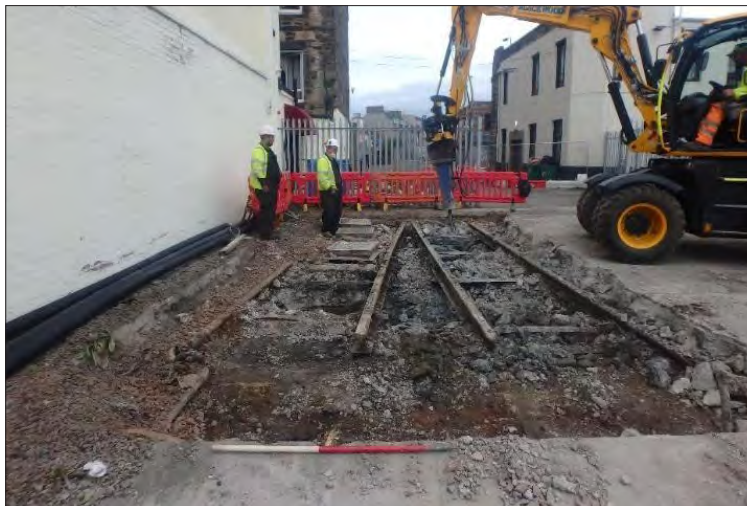
*Plate 40: Removing the concrete floor of the bus station to reveal the old tram tracks encased in concrete*

- 6.42 There were concrete surfaces associated with the chambers and these usually consisted of two layers, the base layer formed a level surface and the tram tracks were laid on the top layer. A small area of a cobbled surface was also recorded underneath the old tram track and therefore pre-dates the tram depot.

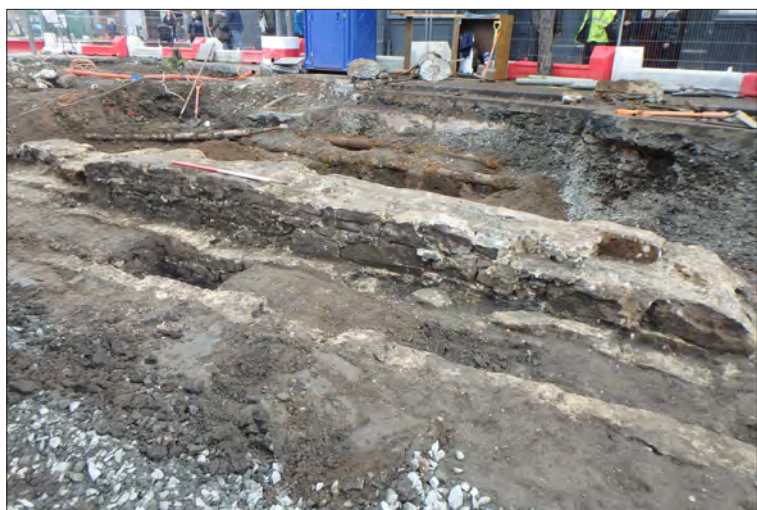
Plate 46: North-west facing section of tenement wall (8830) and associated drainage at the Foot of the Walk

measuring up to 420 mm by 600 mm by 140 mm in size and bonded with a grey white lime mortar (8830). Two trial trenches were excavated on either side of the wall. In the trench at the east facing section of the wall, the foundation trench for the wall (8833) was uncovered filled with a 0.7 m thick layer of sub-angular large roughly shaped stones, but it had been truncated by services. In the west facing section a culvert for drainage was uncovered parallel to the wall. The culvert (8331) was 7 m long by 0.9 m wide and 0.49 m deep. It was built with rectangular large sandstone blocks (ranging from 360 mm by 180 mm by 160 mm to 460 mm by 190 mm by 60 mm) bonded with a grey white lime mortar; no capstones were found covering the drain.
